# Service Bulletin

SB 221 - January 2007

## SUBJECT: 17162 Ford F250/350 4WD Mounting Carton

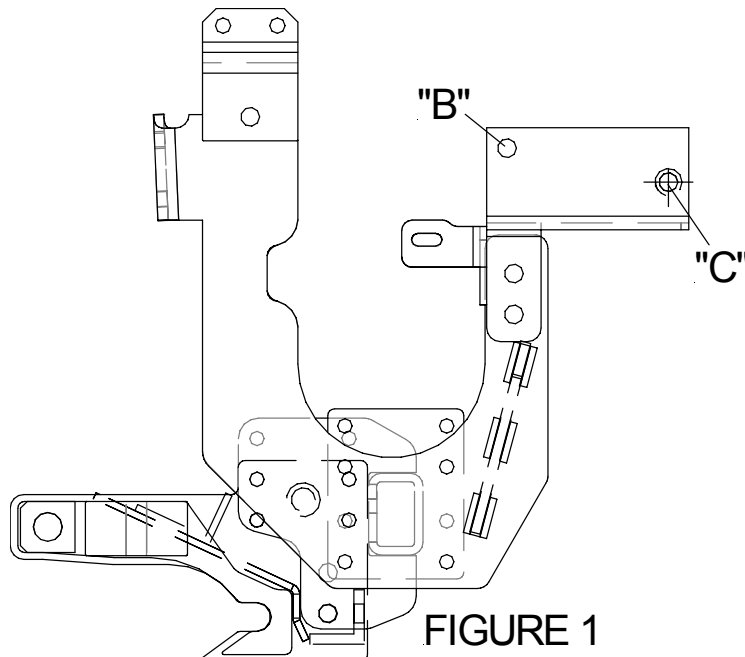
Meyer Engineering has discovered a possible hole alignment issue when installing the 17162 on the Ford F250/F350 driver's side mount assembly P/N 19731 Mount Assembly (driver's side) onto the 2007 vehicle frame. Installation of the mount assembly requires additional holes to be drilled in the vehicle frame.

While holding mount assembly tight to the bottom and side of the vehicle frame scribe hole locations to be drilled at "B" and "C" per illustration. FIGURE 1

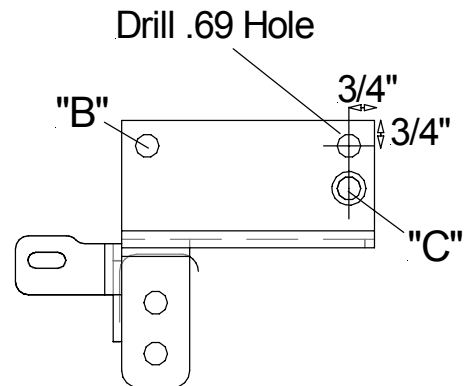
FIGURE 2

Please take note when scribing hole "C" location. Depending on the individual vehicle frame tolerances, hole "C" in the P/N 19731 mount assembly maybe located too close to the steering gear mounting bolt. If this is the case, drill a new hole in the P/N 19731 mount assembly bracket per illustration FIGURE 2. Repeat steps in Paragraph F using the new hole in mount assembly. Continue to follow the installation instructions on form 1-873 until installation is complete.
